Inspector's Daily Report

IDR Sheet	1	of	1	Sheets	Final Record Book	Page
Contract	C-7852			Day	Monday	
				Date	August 22, 2011

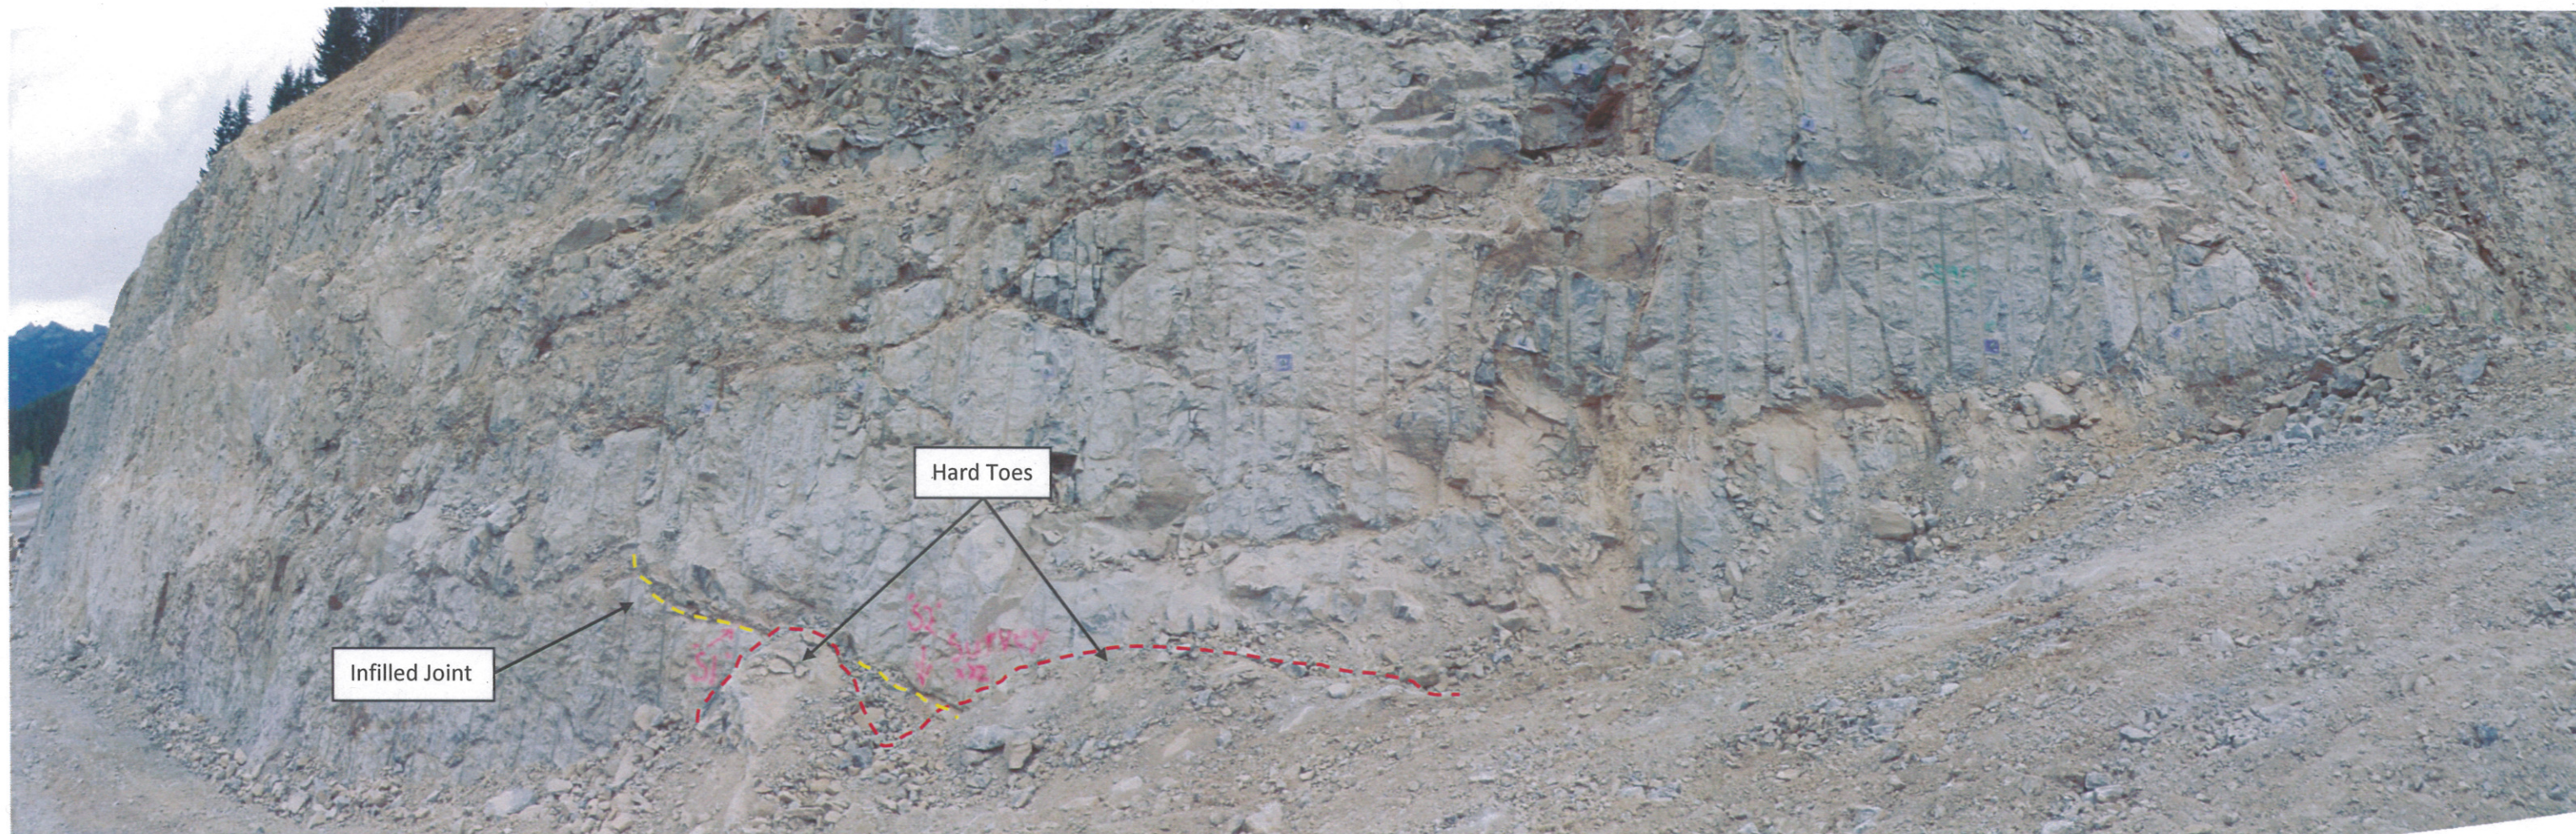
Erik and I walked to station 1330+10 to assess the site. Unfortunately, the infilled joint is located in the area of two hard toes and dives behind the most eastern hard toe (Figure 1). It appears that even if the smaller back hoe was available, it would be unable to reach as far down as needed on the eastern side of the hard toe to find the infilled joint.

Figure 1. A photograph showing the infilled joint (dashed yellow) and the hard toes (dashed red) around station 1330+10. We are unable to map the extent of infilled joint to the east behind the hard toe.

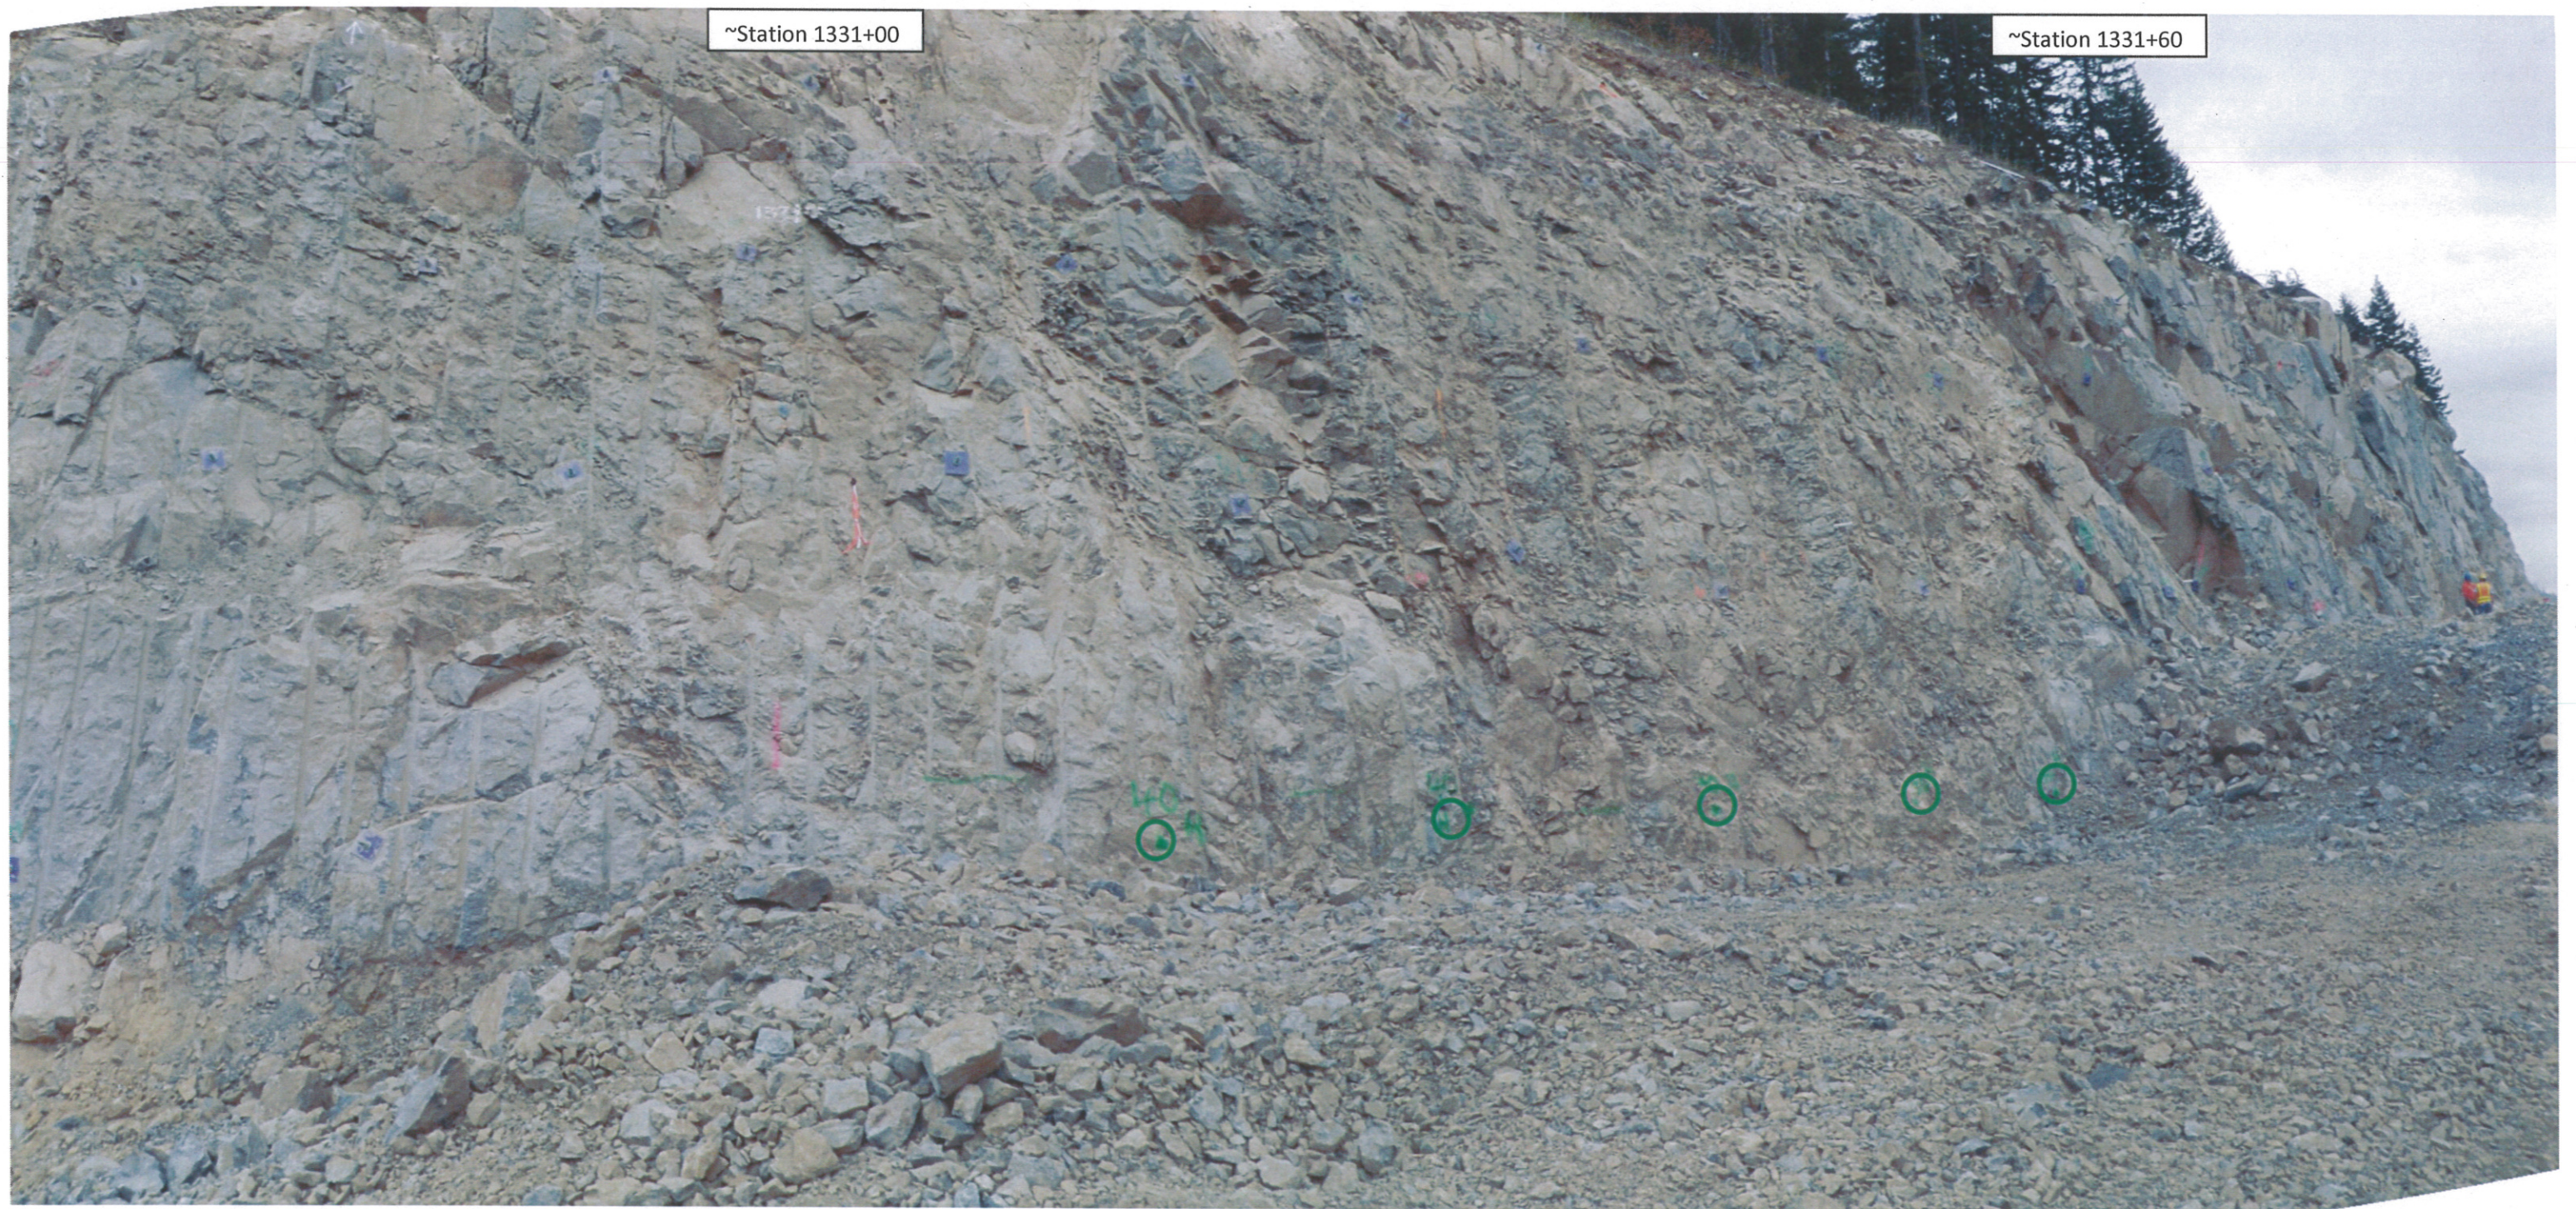
While I was on-site, I walked upslope and noticed that the type H dowels that Eric Smith laid out last week, from station 1331+00 to 1331+60, had not been installed as was previously informed to the Geotechnical Division (Figure 2). A production shot is planned for tomorrow night, immediately to the east of these dowels. I informed Erik that these dowels may need to be installed prior to tomorrow's production blast. I told Erik I would relay this information to the Geotechnical Division and discuss the situation.

Figure 2. A photograph showing the previously laid out type H dowels from approximate station 1331+00 to 1331+60.
